Urgent Field Safety Notice

Software Distribution Network & Associated Programmers

Product Name	Model Number
CareLink™ 2090 Programmer	2090; All Serial Numbers
CareLink Encore™ 29901 Programmer	29901; All Serial Numbers

October 2018

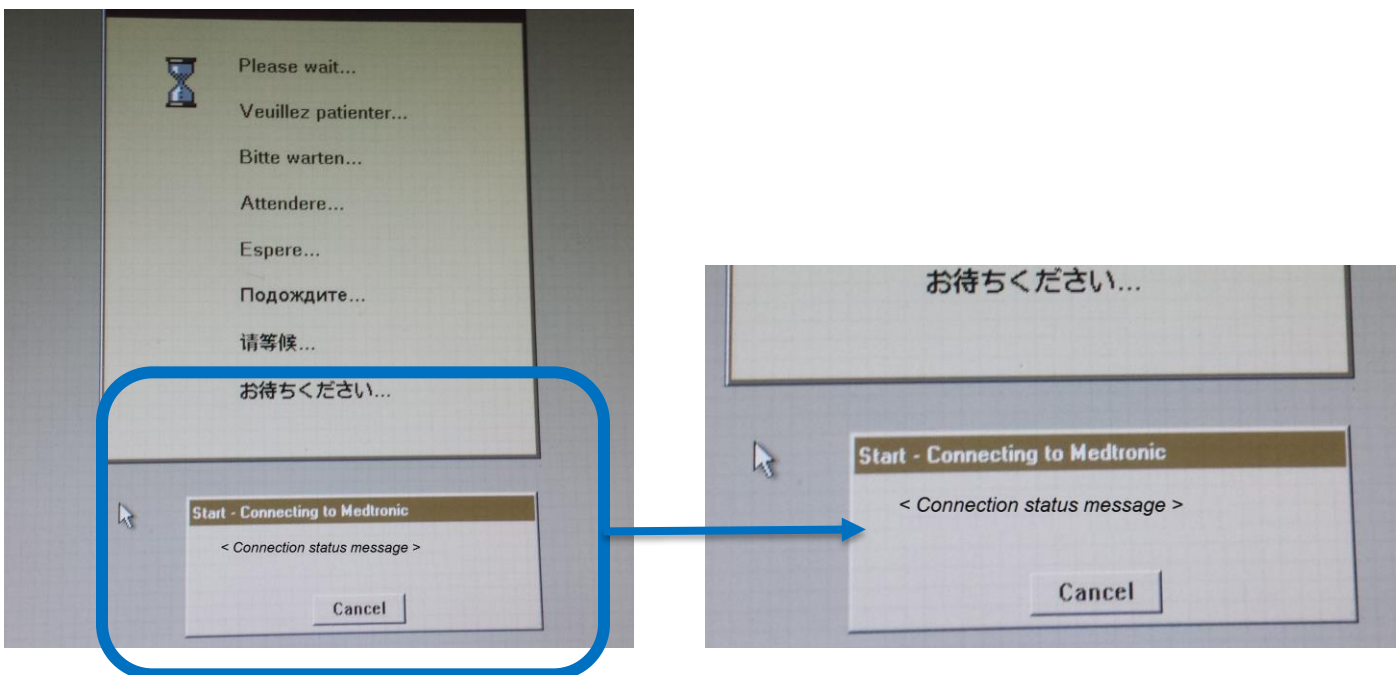
Several messages may be observed if installation of software from the SDN is attempted (e.g. "Install from Medtronic..."). See images below for example as to what will appear on the programmer display during the installation attempt. Below the larger "Please Wait" message will be a smaller window with a <connection status message> displayed; refer to highlighted area below. The connection status messages may alternate *between* "Connecting...", "Searching for Network...", "Logging in...", "Unable to connect to local network", and "Unable to connect to Medtronic". Since the SDN is no longer available, **the user should select "Cancel" to terminate the installation attempt.**

If the user cycles power on the programmer without first cancelling the installation attempt, upon power-up a count-down window will appear on the screen for approximately 30 seconds with "Yes" and "No" buttons. The user should select "No" to terminate the installation attempt and return to the Model Select screen. If the user selects "Yes" or does not respond prior to the 30-second time out, the programmer will attempt the installation again, and the process described above will repeat until the user either selects "Cancel" or selects "No" during the count-down window.
