الموضوع: إشعار بمتابعة جهاز طبي مغروس

Urgent Medical Device Field Safety Notice

ISOLINE defibrillation leads, model 2CR5, 2CR6 and 2CT6

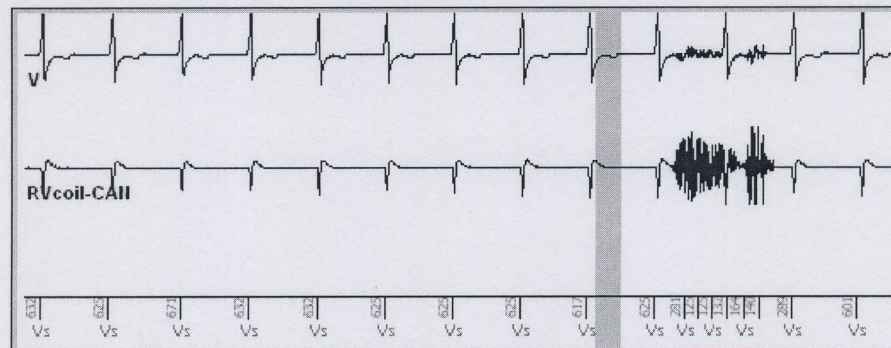
Ventricular oversensing caused by external signals (such as 50 Hz Electro Magnetic Interferences):

Such episodes are not related to lead malfunction. If such an episode is recurrent, avoidance of the source of interference is recommended.

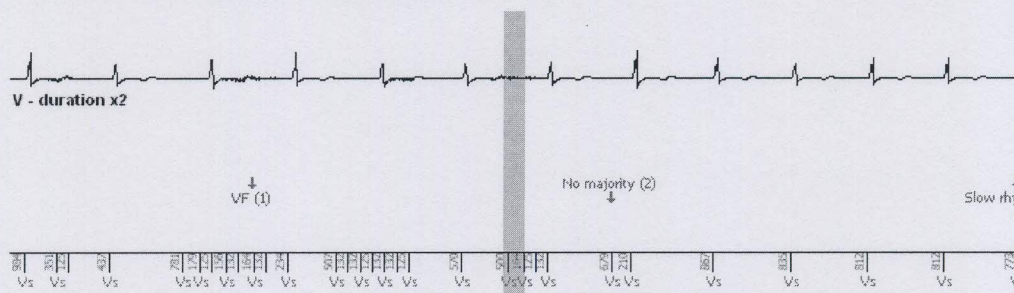
Ventricular oversensing caused by myopotentials:

Such episodes are not related to lead malfunction. If such an episode is recurrent, sensitivity should be adjusted.

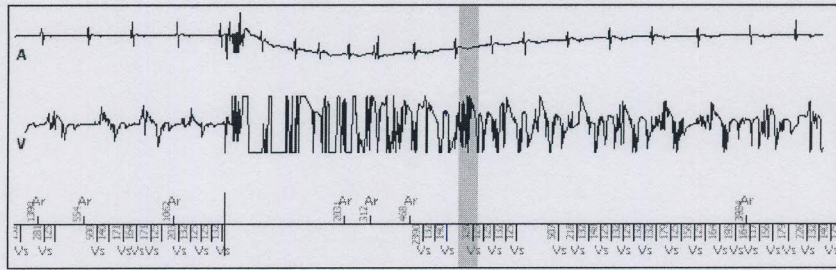
Ventricular oversensing caused by lead issue:

- In case of evidence of a lead issue (as shown in the appendix), physicians should consider replacing the lead, while weighing the risks and benefits of extracting the

lead compared to capping it and leaving it in place. The decision to remove a lead should be taken on an individual basis, as described in HRS guidelines⁵. Any event associated to a potentially defective ISOLINE lead should be reported to Sorin CRM; any extracted lead should be returned to Sorin CRM for analysis.
