Urgent Field Safety Notice

Commercial name of the affected product:	Keeler CRYOMASTER cryosurgical console – MOD 1, MOD 2 and MOD 3
FSCA identifier:	CAPA 1091 (MHRA ref 2013/012/016/081/003)
Type of action:	Advisory Notice
Date:	20/1/2014
Attention:	Distributors and Users
Transmission of this Field Safety Notice:	This notice must be passed on to all those who need to be aware within your organisation; This must include: Quality/Regulatory, Theatre, Maintenance

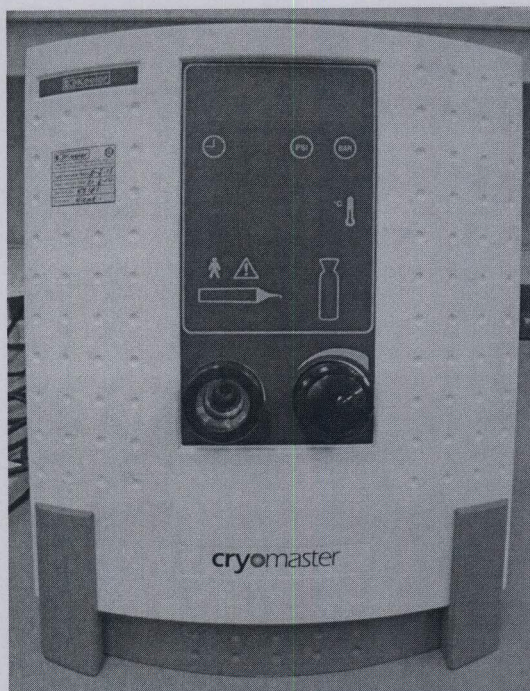
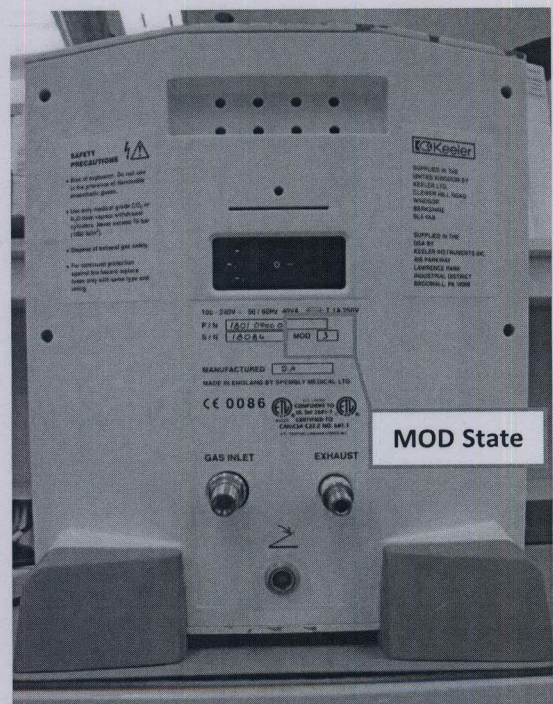
Keeler Ltd has recently been made aware of a potential problem with certain versions of the Keeler Cryomaster whereby immediately after footswitch operation the device can revert to a purging state. During this time it may not be possible to easily break contact with the patient's eye, with the potential for damage to the affected surface of the eye.

Affected devices are labelled "**MOD 1**", "**MOD 2**" or "**MOD 3**" on the Serial Number label on the rear of the unit. See pictures below.

This behaviour is caused by a contact in the probe detection mechanism momentarily breaking a circuit. The unit then erroneously detects a probe disconnection and re-connection, and initiates an unwanted purge cycle.

1. Cease use of the Keeler Cryomaster unit with immediate effect.
2. Clearly label the device ‘**DO NOT USE**’, and remove from service.
3. Contact your supplier/dealer for assistance.
4. **PLEASE COMPLETE THE FORM ON THE FOLLOWING PAGE AND RETURN TO KEELER USING THE CONTACT DETAILS PROVIDED.**

This problem can be remedied by replacement of the contact in the probe detection mechanism. This can be carried out by the Keeler Technical Services Workshop at its factory in Windsor.
