Urgent: Field Safety Notice
Update to October 2016 Field Action:
Important information regarding the Medtronic Model 37751 Recharger
(Included in Kit Models 37754, 97754, and 37651)

February 2019

Medtronic reference: FA735 Phase II

MODEL 37751 RECHARGER RESET INSTRUCTIONS

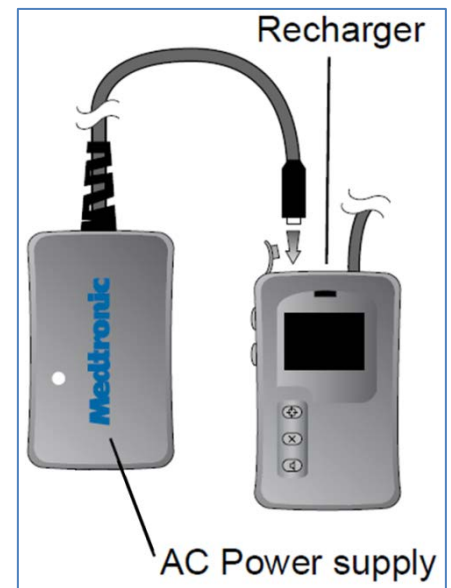
- For product manufactured prior to the design change (Serial numbers starting with "4" [e.g. "NKA4" or "NKU4"]):
 - To prevent this unresponsive error state, the Recharger should be plugged into the AC power supply (by aligning white triangles) prior to starting a recharging session of the neurostimulator and remain connected to the AC power supply until the recharging session has finished (see Figure 1). Note: The AC power supply does not need to be plugged into a power outlet if the Recharger is charged.

- For product manufactured after the design change (Serial numbers starting with "5" [e.g. "NKA5" or "NKU5"]):
 - Follow the instructions included with the Charging System user manual shipped with the device. Instructions in the user manual do not require the Recharger to be plugged into the AC power supply for a recharging session to occur.

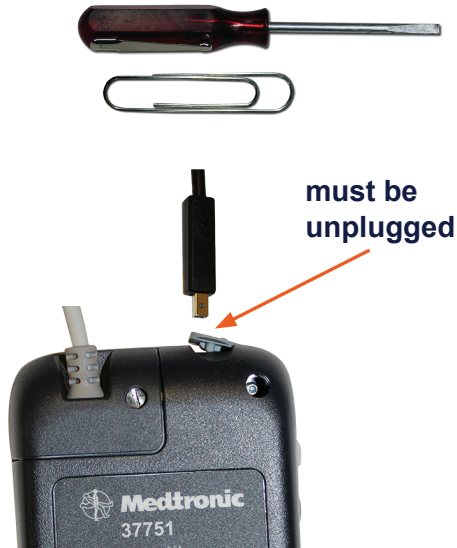
1 WHAT YOU NEED

- small Flathead screwdriver
- standard paper clip

Recharger must be unplugged.
Do not reset the recharger while it is plugged into the AC power supply.

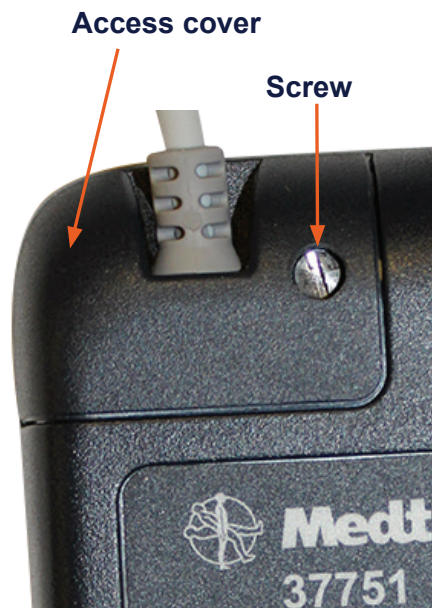
2 REMOVE ACCESS COVER

Use small Flathead screwdriver to unscrew and remove access cover.

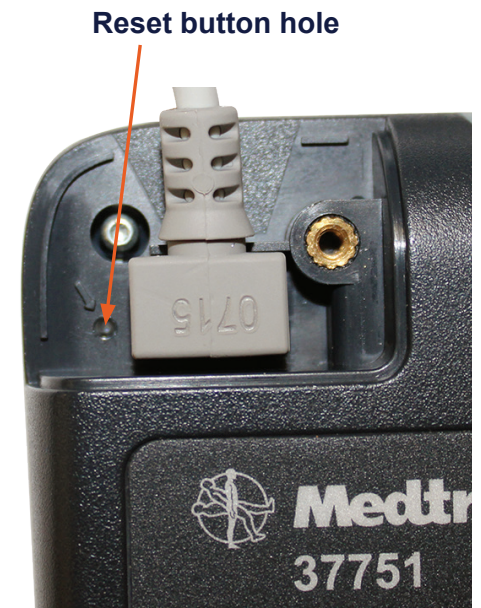
3 LOCATE RESET HOLE

Locate reset button hole.

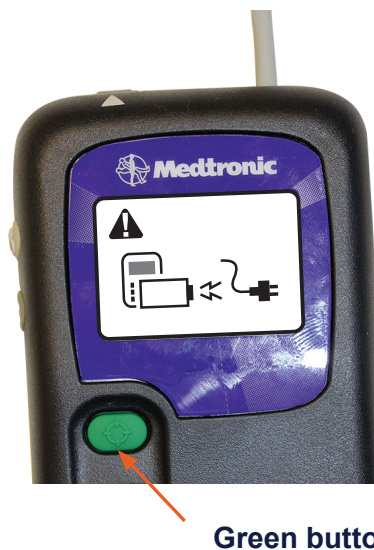
5 CLEAR SCREEN

The recharger displays the AC Recharge screen. Press the green button to clear the screen.

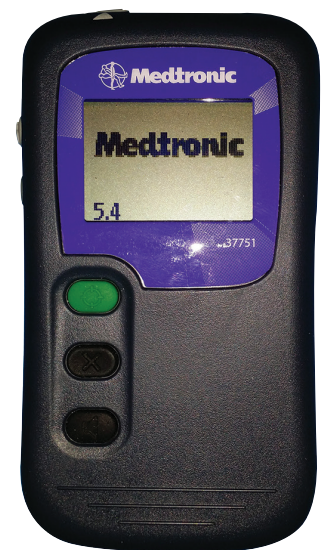
6 CONFIRM RESET COMPLETE

Press the green button again to start a charging session. If the recharger does not function, contact your Medtronic Representative.
