## Urgent Field Safety Notice

### Update to Address SynchroMed II™ Pump Memory Error Via Model A810 SynchroMed™ II Software Application Version 1.1.342 Software Update

Medtronic Reference: FA921

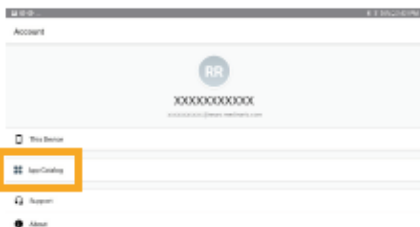
1. Click on **Hub** app. Then select **App Catalog** to view apps available for installation or update.
